Signs of End of Life FM Antennas and Transmission Line Systems

Thomas B. Silliman, PE

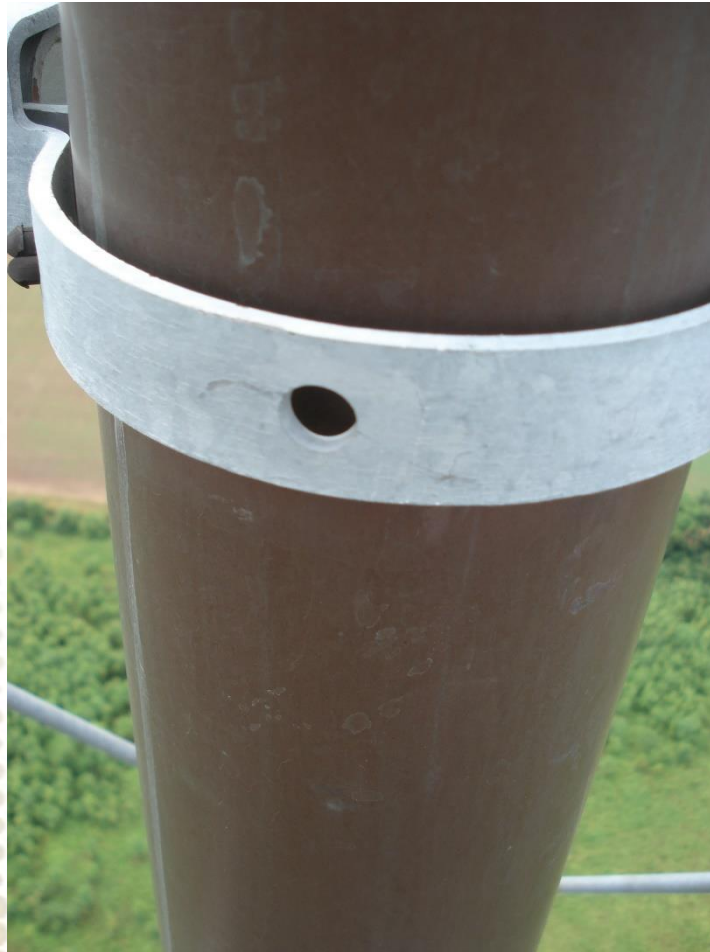
Inspection of feed line showing missing button

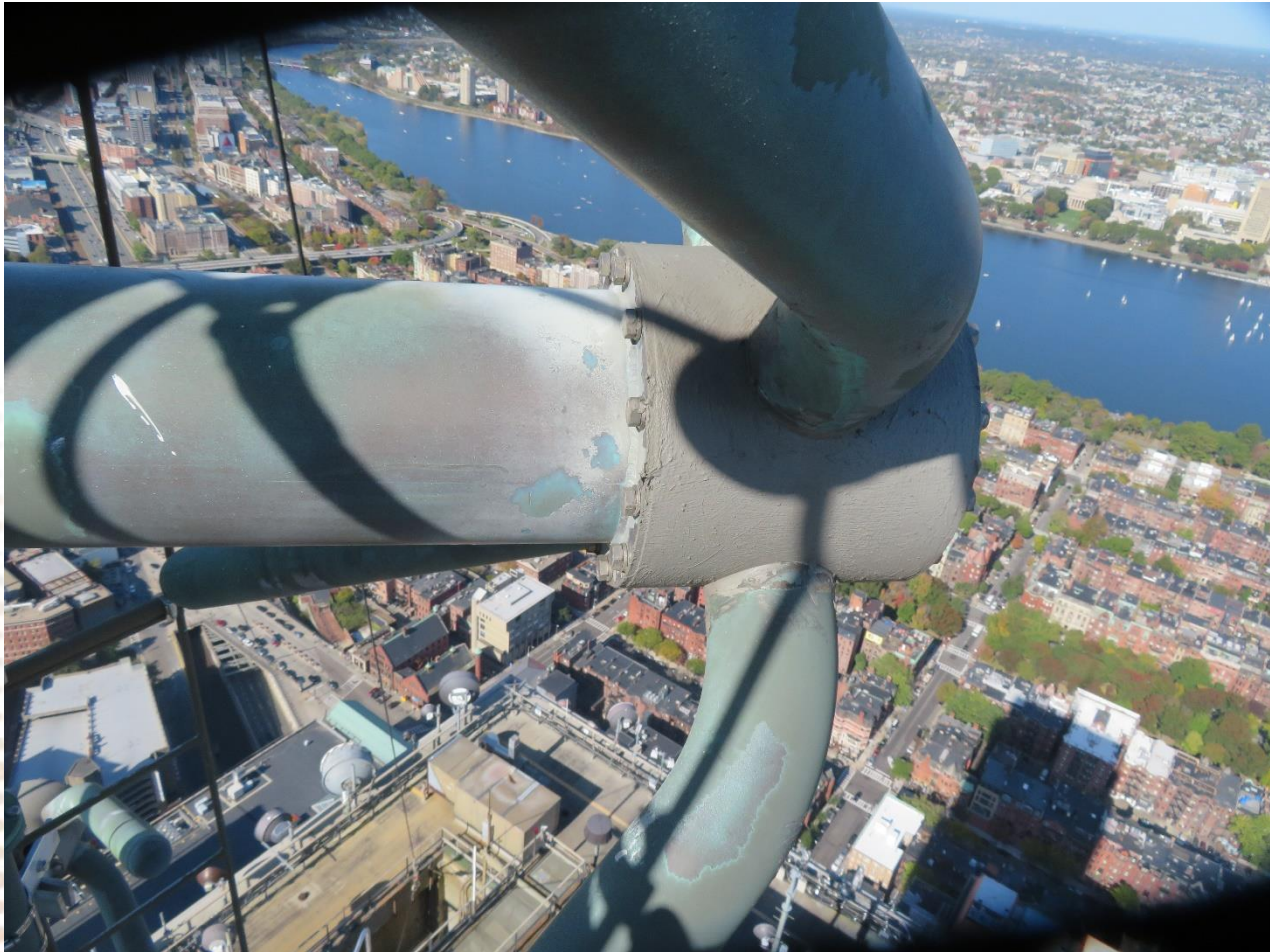
Inspection of Multiplex Painted Antenna Insulator

- Antenna and tower inspections
 - Many FM multiplex antenna systems are inspected annually.
 - Broken hangers
 - Pressure leaks
 - Worn out insulators or insulators that need to be coated
 - Most single station side mount antennas are only inspected if a problem occurs
 - VSWR
 - Pressure loss

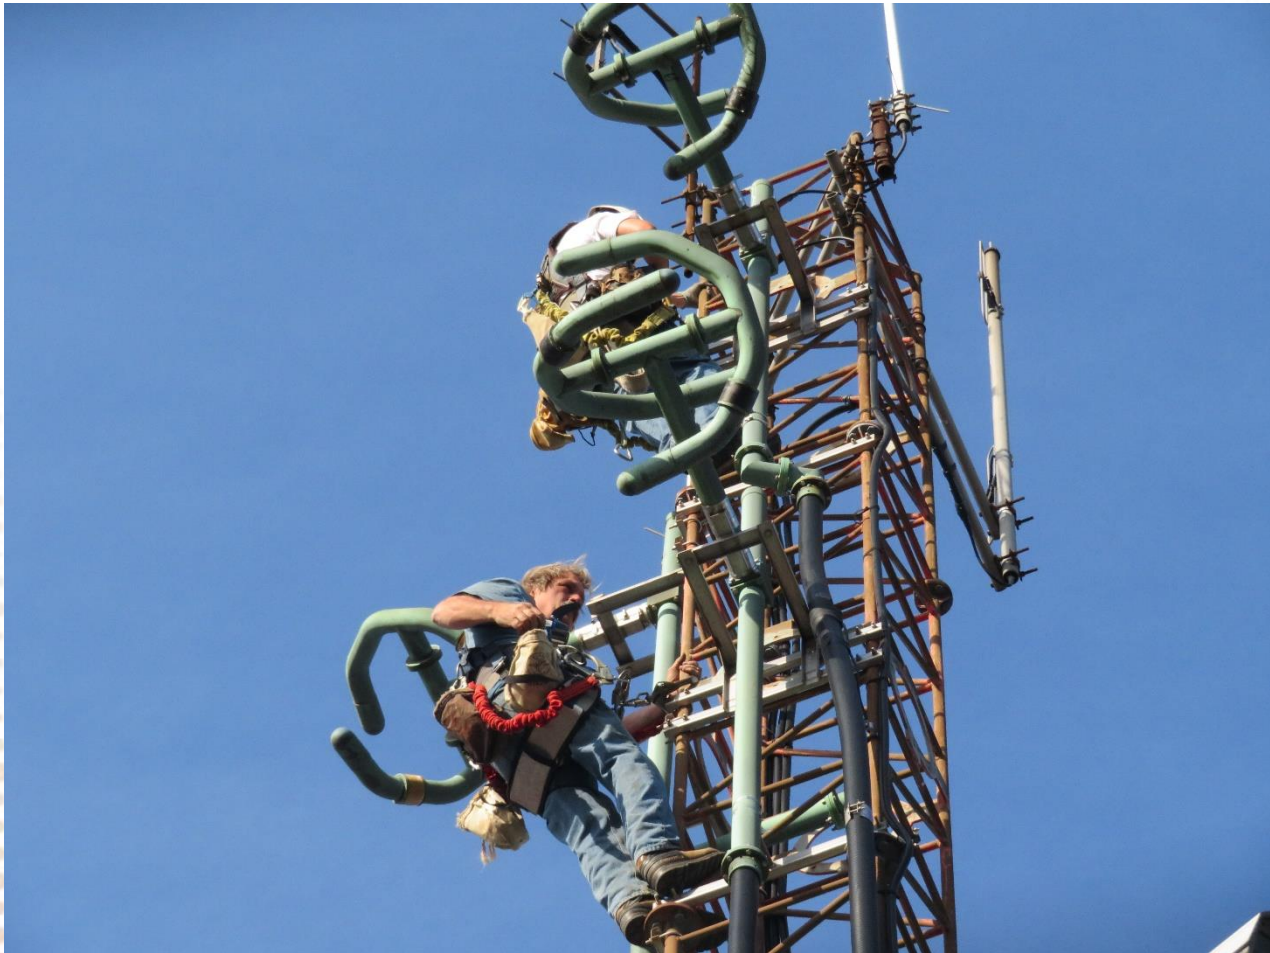
Antenna Inspection of Side Mounted FM Antenna

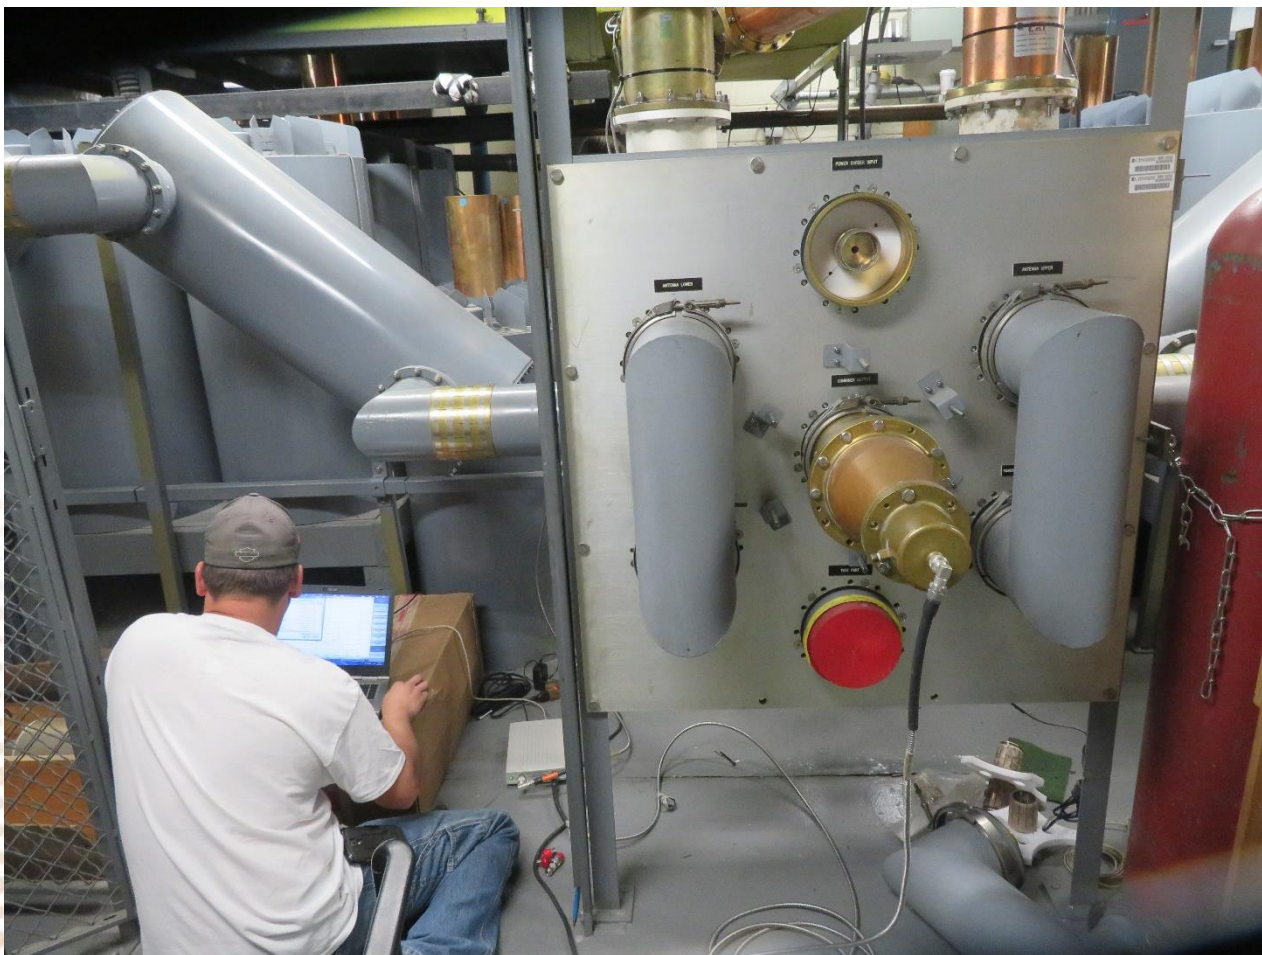
Antenna Inspection Measuring All Components

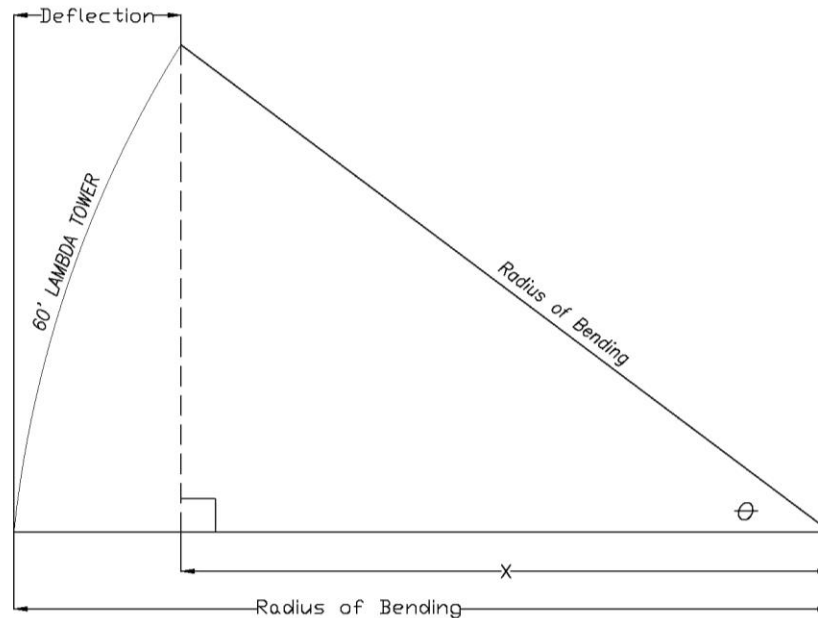
Example of Tower Movement Calculation

Sample Calculation of Lambda Deflection

- Assume a 60 foot tall Lambda Tower
- Specification of radius of curvature for the Lambda Tower is $R = 3000$ feet at full wind design under G
- $R(\Theta) = 60$ feet where Θ is radians
- $\Theta = 0.02$ radians = 1.1459 degrees
- $X = (3000) \cos 1.1459 = 2999.4$ feet
- Deflection = $3000 - 2999.4 = .6$ feet
- $.6$ feet = 7.2 inches

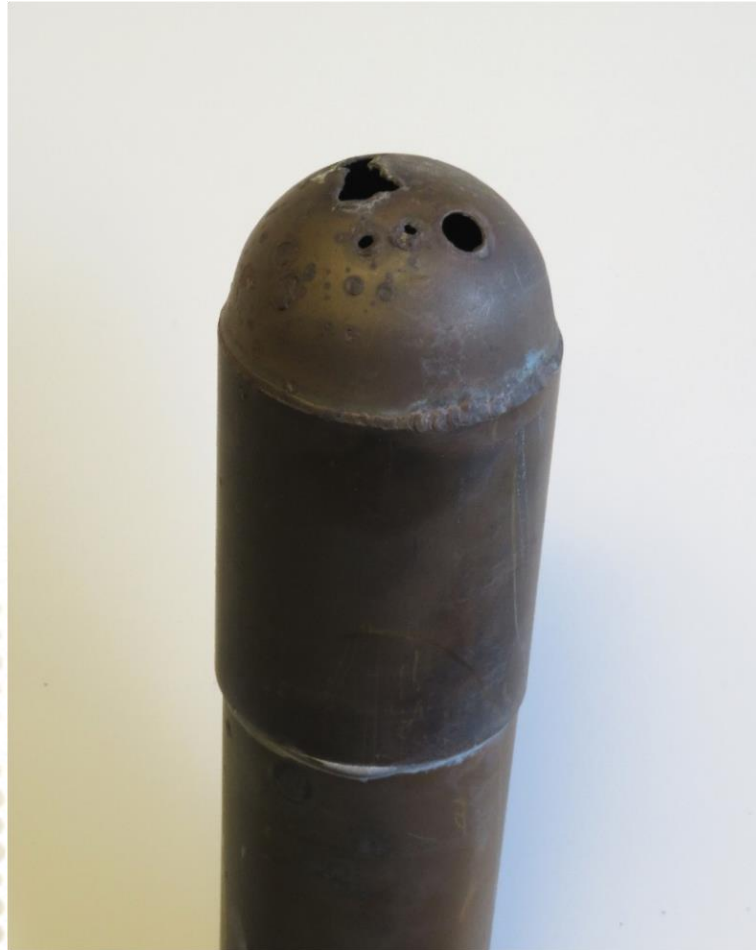
Lightning Damage

- Symptoms
 - Loss of pressure
 - High VSWR
- Can allow moisture to enter antenna and transmission line.
- Does not necessarily have an adverse affect on the life time of the antenna or transmission line if repairs are done quickly.

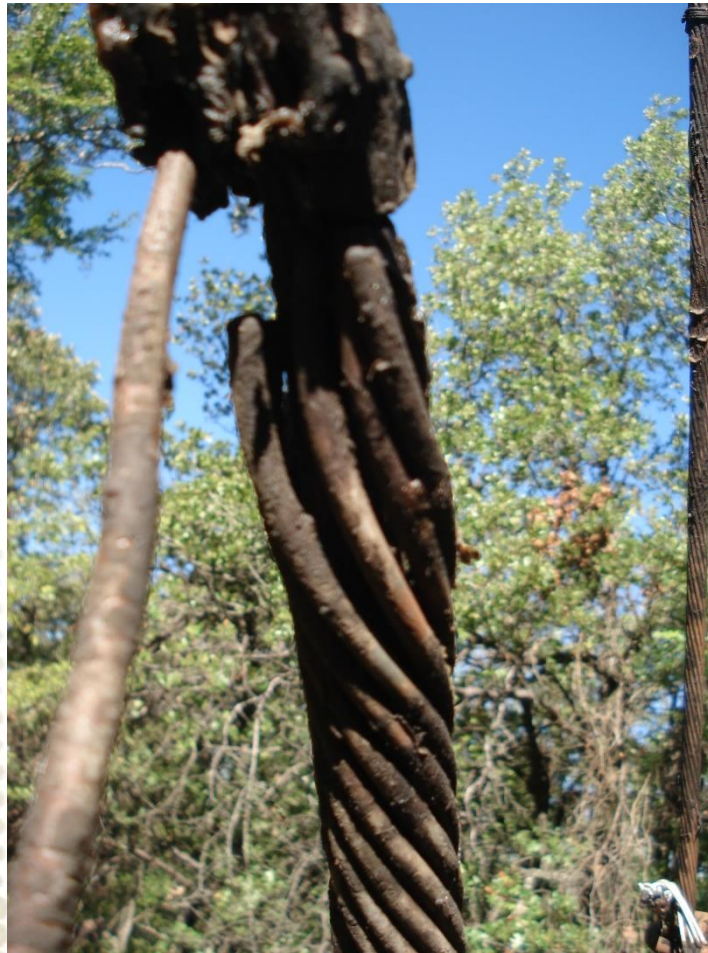
Example of Guy Wire Deterioration

- Will affect antennas located near ocean
- Radomes can be added to the antenna to protect insulator surface
- Towers near sea coast should be inspected every five years
 - Guy wire deterioration
 - Leg steel
 - If hollow legs, can deteriorate leg steel.
 - Inner members can rust if not protected.

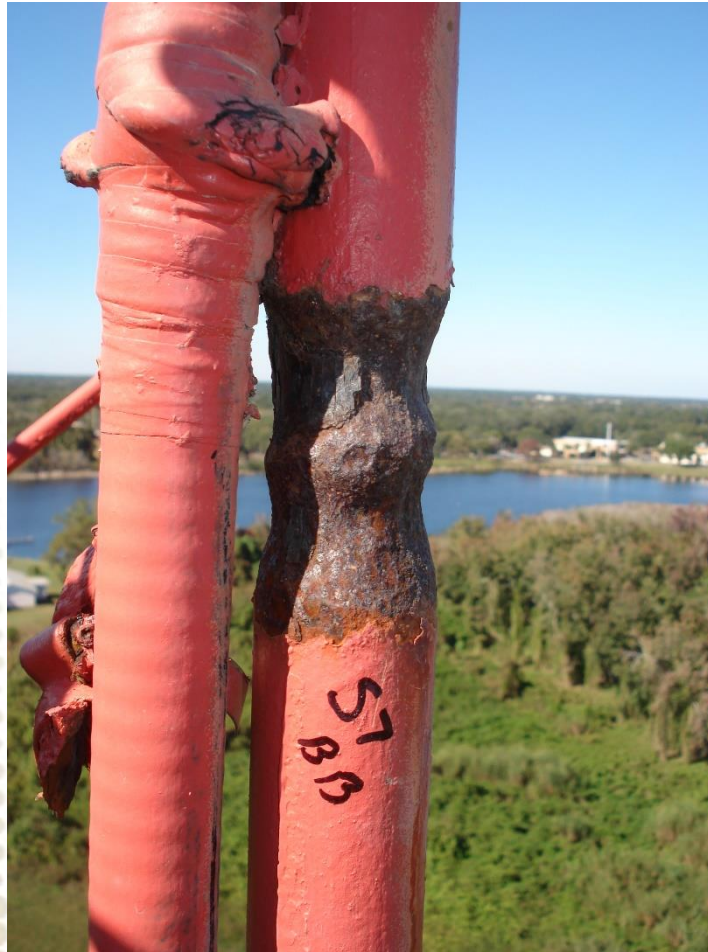
Example of Tower leg Deterioration

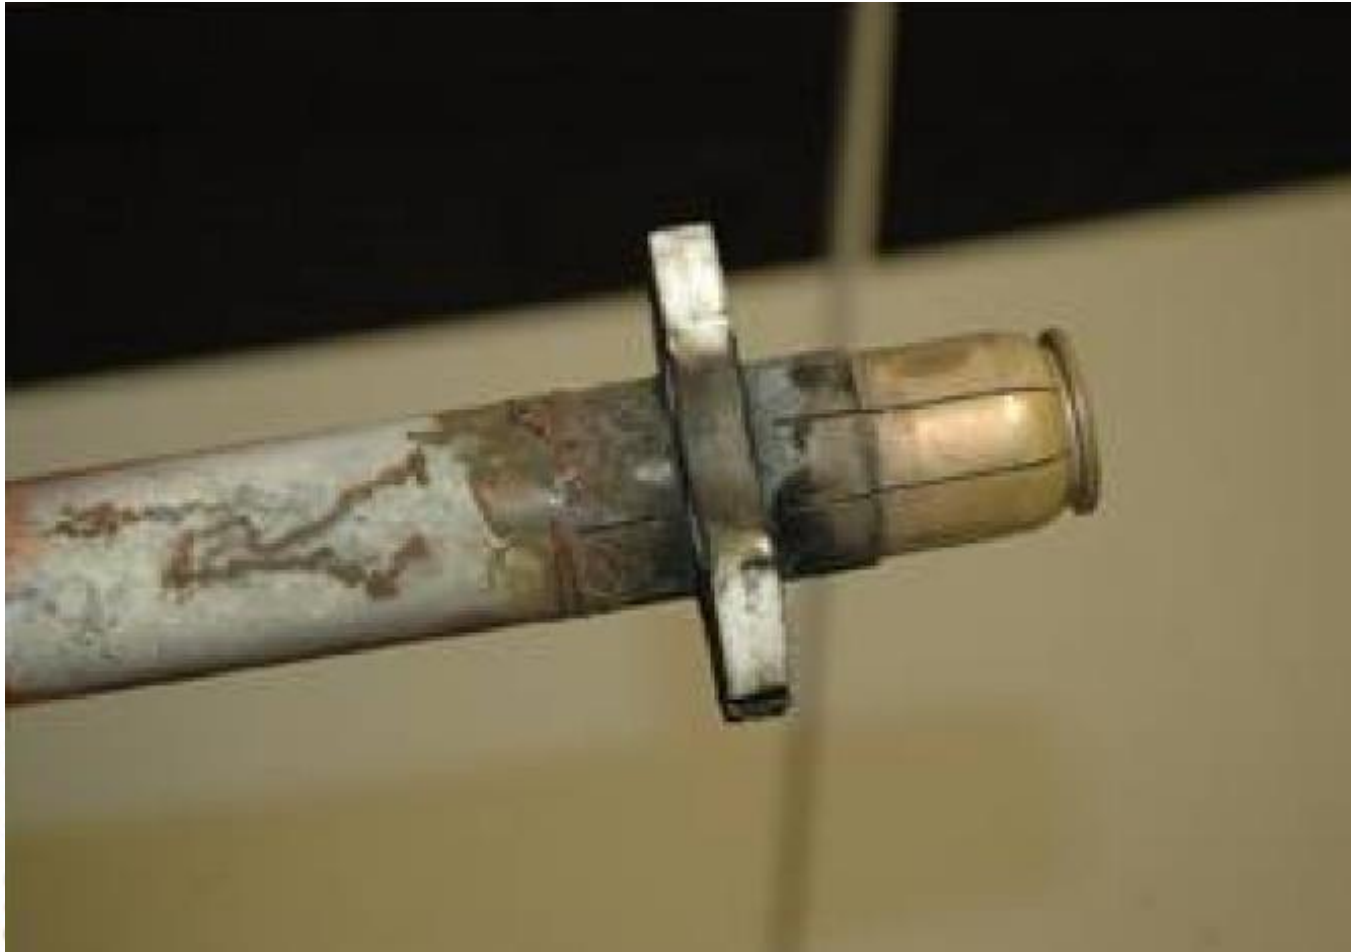
Example of Bullet Failure

- FM antennas have inner connector connectors, bullets.
 - As temperature of inner conductor changes, the inner conductor will expand and contract differently than the outer conductor.
 - Temperature varies due to outside air temperature
 - Temperature varies when antenna input power is turned off and then turned on at a later time.
 - Excessive movement of inner causes bullet₁₉ failure.

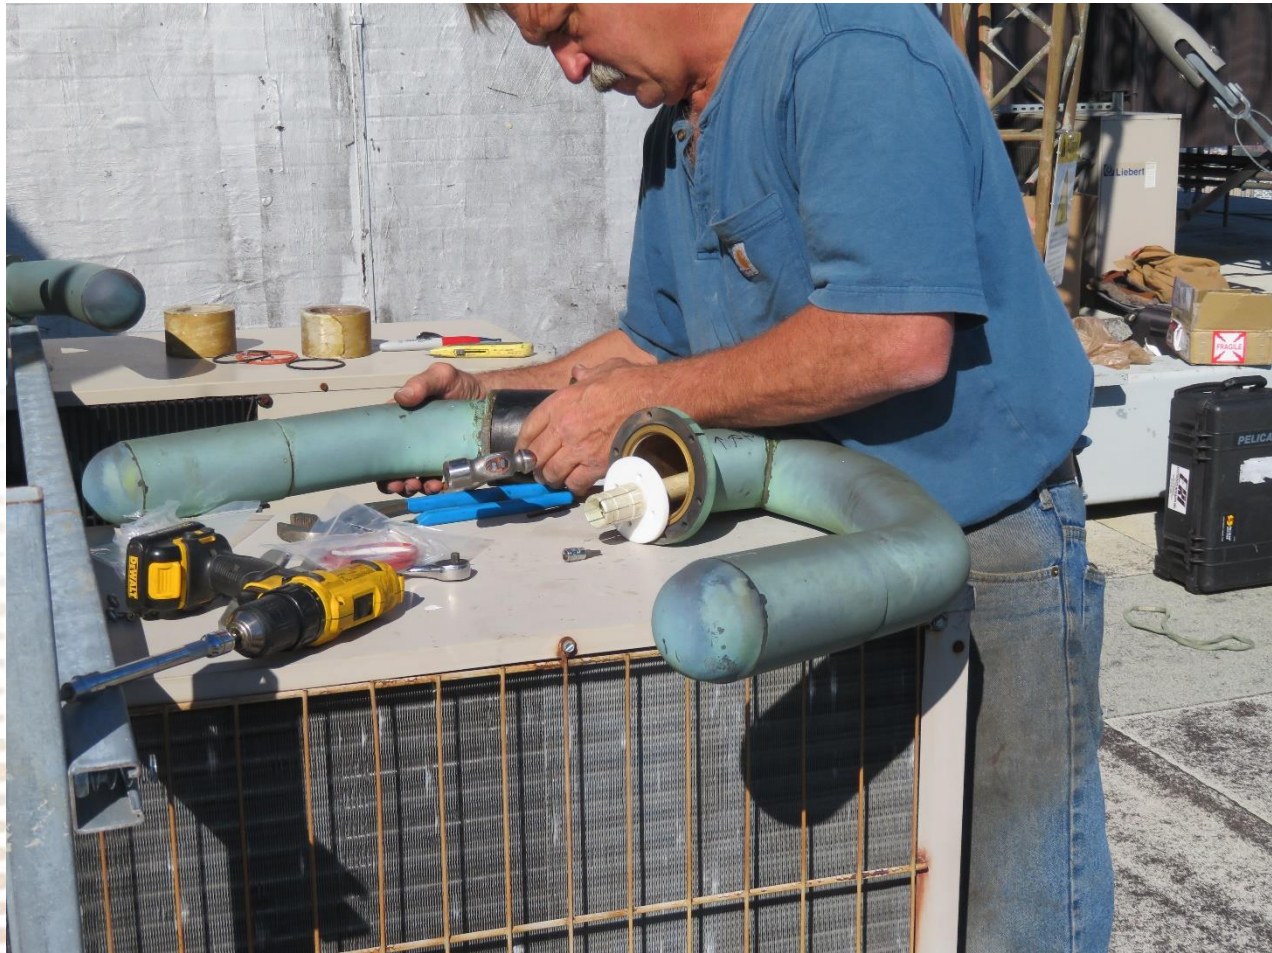
Antenna being Rebuilt in the Field

- Antennas can be repaired or rebuilt to extend the life of the antenna.
 - New bullets
 - New insulators
 - New inner conductors
- Rigid coax can also be rebuilt to extend its life.

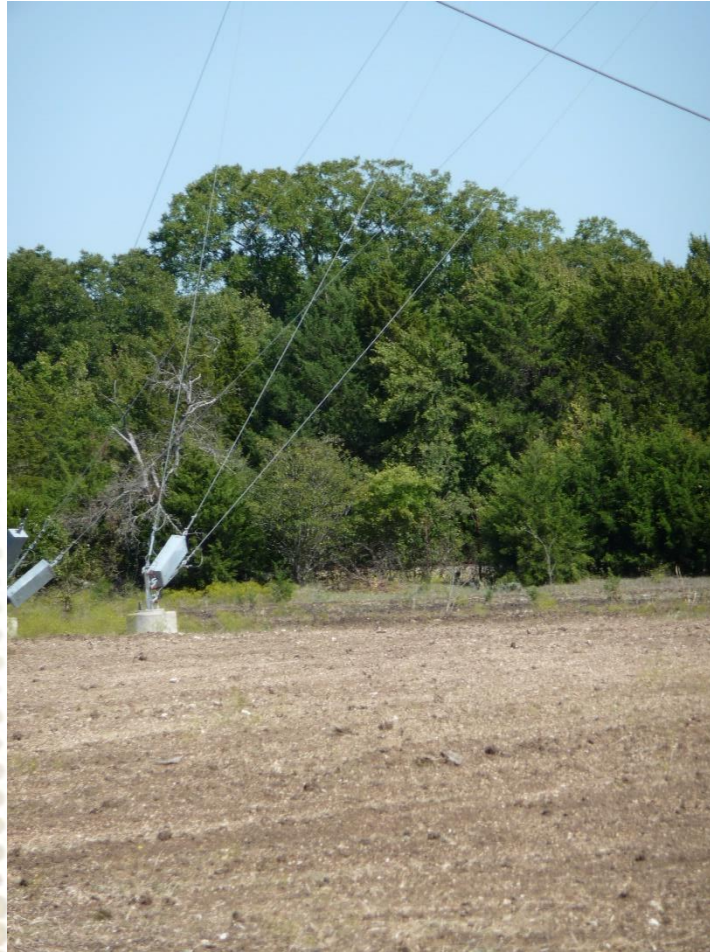
Guy wire Snubbers

- Significantly reduce guy wire galloping.
- Cables ride up and down on the guy wire near the anchor on pullies.
- These cables are attached to shock absorbers that are anchored to the ground near the guy wire anchor.
- Are often used on tall towers 1000 feet tall and taller.
- Can be added to existing towers.

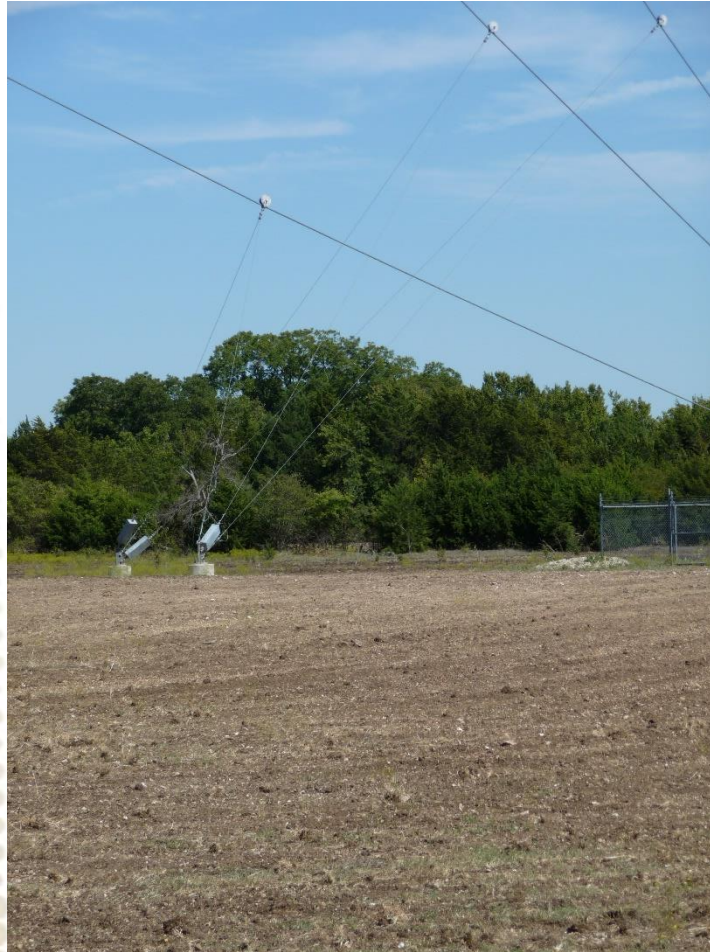
Guy wire Snubbers

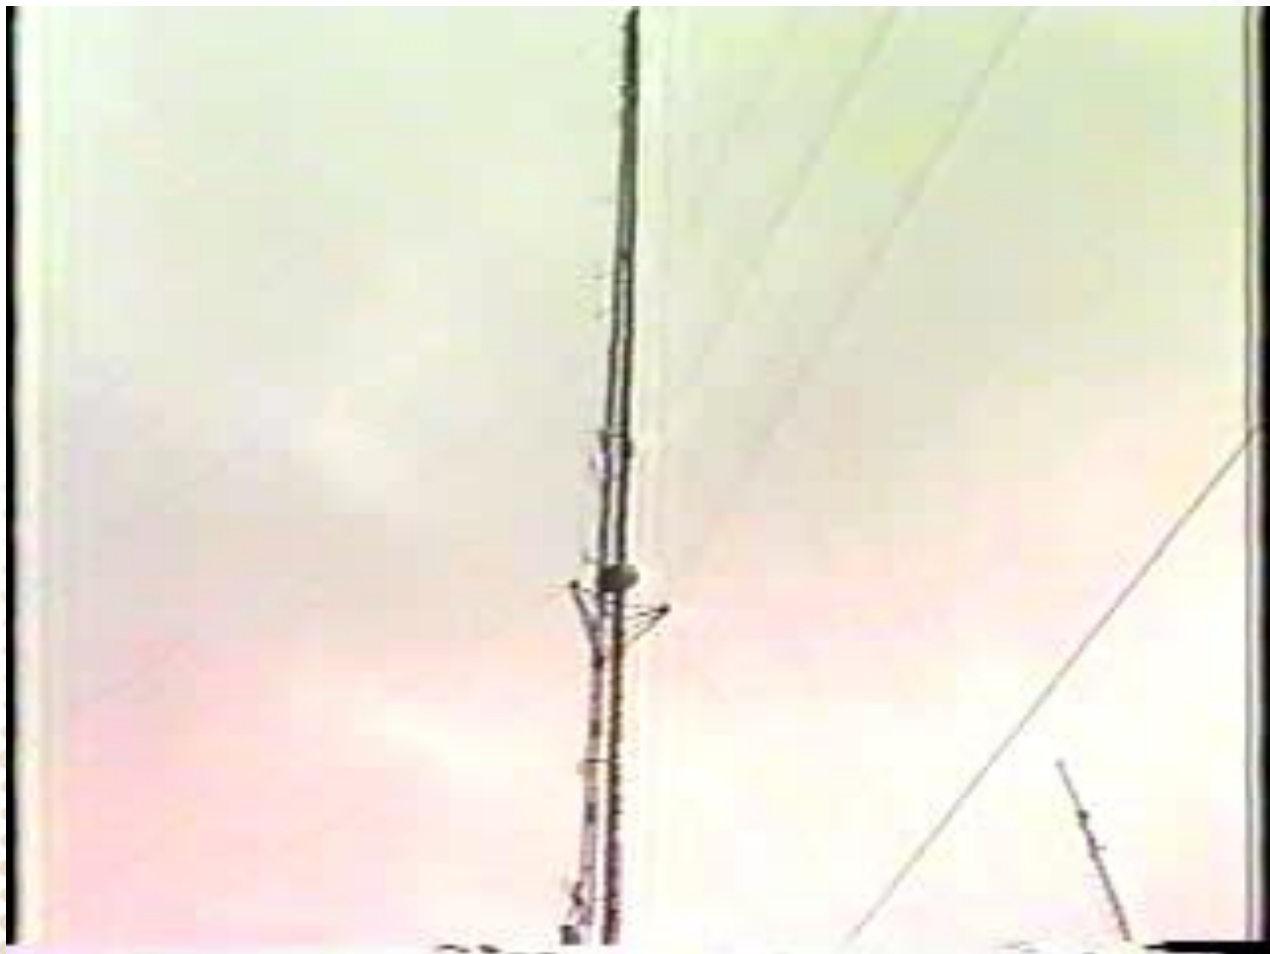
Guy Wire Galloping Video

- Can result when wires are not tensioned properly
- Often will occur with ice on the wires
 - Wind causes ice to form a trailing edge
 - Trailing edge of ice on wire causes lift with stiff wind.
 - Wire will jump up and down shaking the tower which can result in violent antenna movement resulting in antenna damage.
